An Inventory of Irrigation Structures in the Upper Clark Fork River Drainage, Montana

2010 Annual Progress Report
USFWS Agreement Number- 601818J270
Will Schreck, Ryan Kreiner, Brad Liermann, and Jason Lindstrom
Montana Fish, Wildlife and Parks

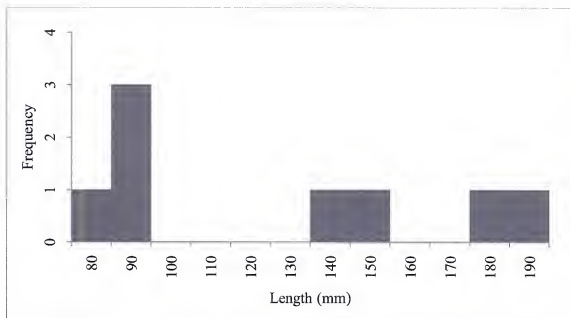
Length distribution of westslope cutthroat trout collected in the ditch at RM 1.1 on Ranch Creek below the headgate in 2009 (n=8).

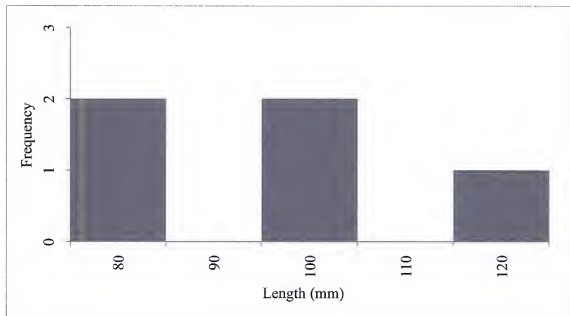
Length distribution of westslope cutthroat trout collected in the ditch at RM 0.1 on Ranch Creek below the headgate in 2009 (n=5).

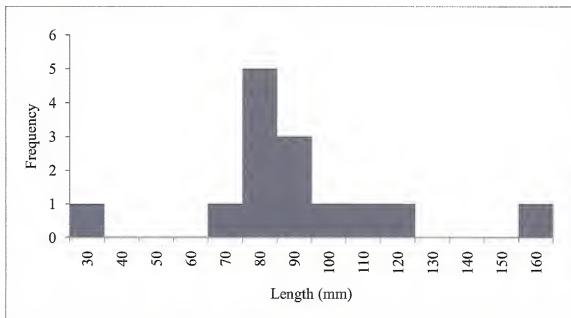
Length distribution of westslope cutthroat trout collected in the ditch at RM 1.1 on Ranch Creek below the headgate in 2010 (n=14).

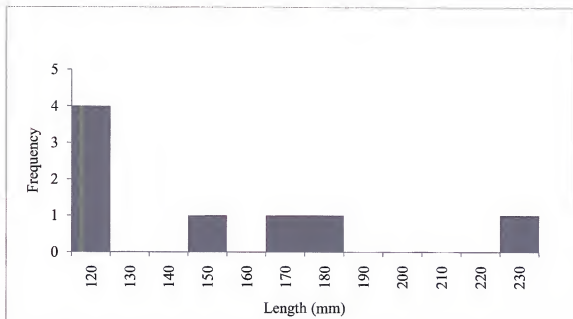
Length distribution of brook trout collected in the ditch at RM 0.1 on Ranch Creek below the headgate in 2010 (n=8).

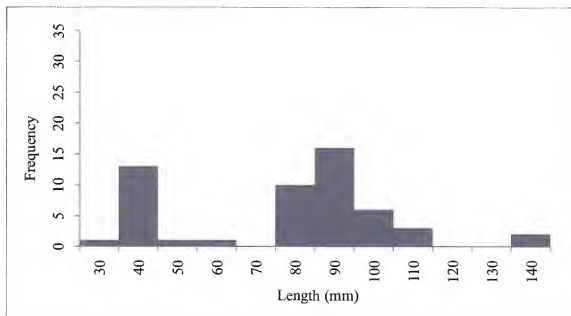
Length distribution of westslope cutthroat trout collected in the ditch at RM 0.3 on Stony Creek below the headgate in 2009 (n=53).

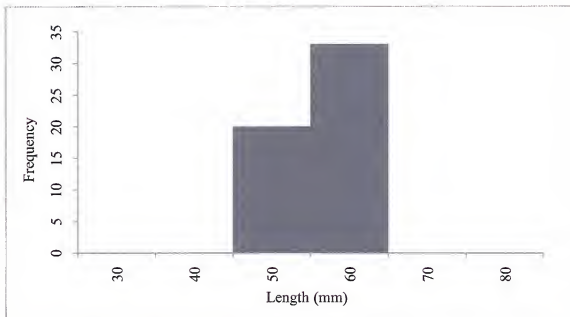
Length distribution of brown trout collected in the ditch at RM 0.3 on Stony Creek below the headgate in 2009 (n=53).

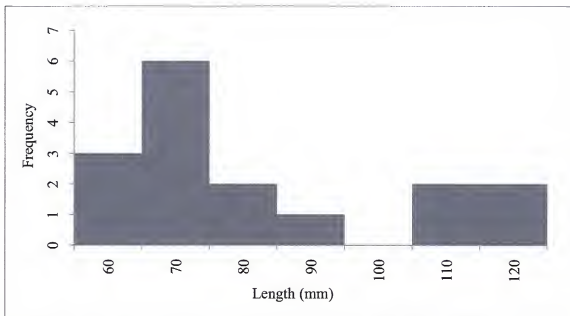
Length distribution of westslope cutthroat trout collected in the ditch at RM 0.9 on Beaver Creek below the headgate in 2009 (n=16).

One irrigation ditch was observed drawing water from Beaver Creek at approximately RM 0.9 (Figure 1). This ditch is outfitted with a metal R-5 style headgate and water is diverted by a check dam spanning the channel (Appendix B). This ditch was electrofished for 100 m below the headgate in 2009 (Table 3). Both brook trout and westslope cutthroat trout were found entrained in this ditch. In total, 16 westslope cutthroat trout and 23 brook trout were collected.

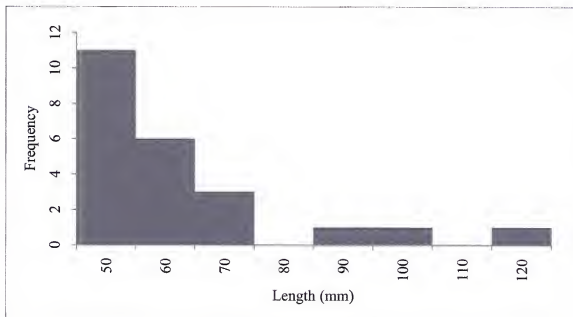
Length distribution of eastern brook trout collected in the ditch at RM 0.9 on Beaver Creek below the headgate in 2009 (n=23).

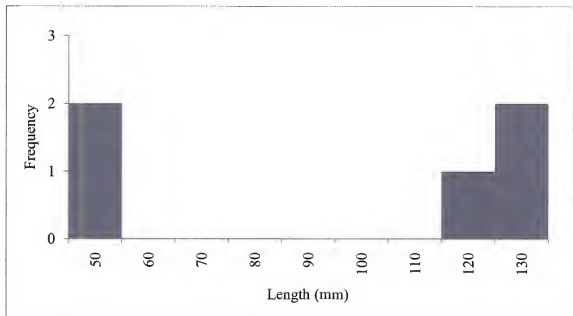
Length distribution of brown trout collected in the ditch at RM 50.6 on Rock Creek below the headgate in 2010 (n=5).

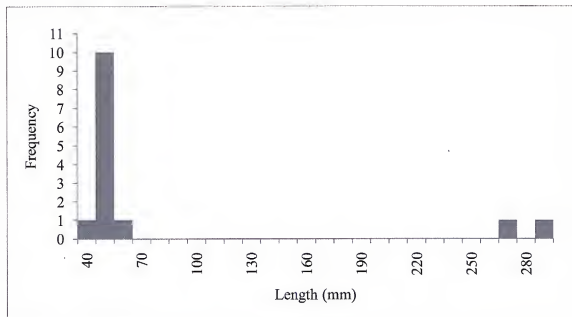
Length distribution of brown trout collected in the ditch at RM 50.5 on Rock Creek below the headgate in 2010 (n=14).

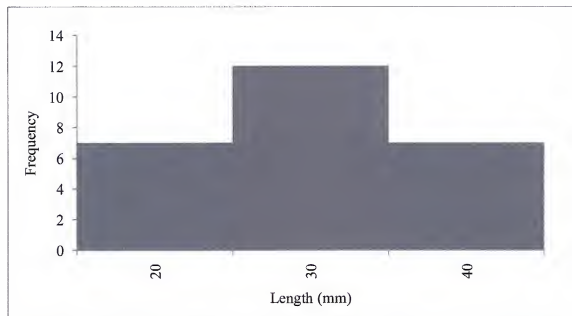
Length distribution of unidentifiable *Oncorhynchus* species collected in the ditch at RM 4.2 on West Fork Rock Creek below the headgate in 2010 (n=26).

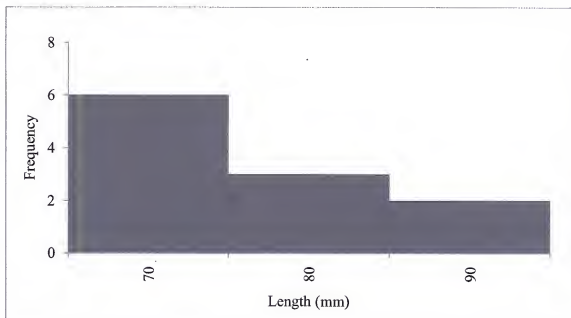
Length distribution of westslope cutthroat trout collected in the ditch at RM 4.2 on West Fork Rock Creek below the headgate in 2010 (n=11).

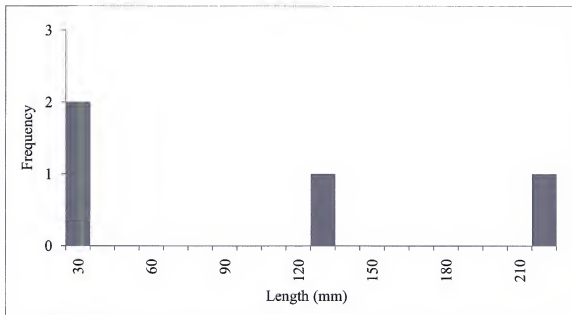
Length distribution of westslope cutthroat trout collected in the ditch at RM 9.4 on Ross Fork Rock Creek below the headgate in 2009 (n=4).

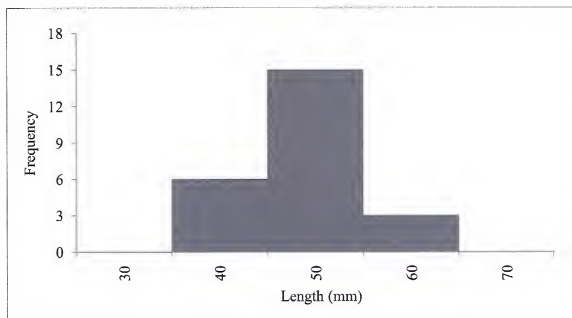
Length distribution of westslope cutthroat trout collected in the ditch at RM 6.5 on Ross Fork Rock Creek below the headgate in 2009 (n=24).

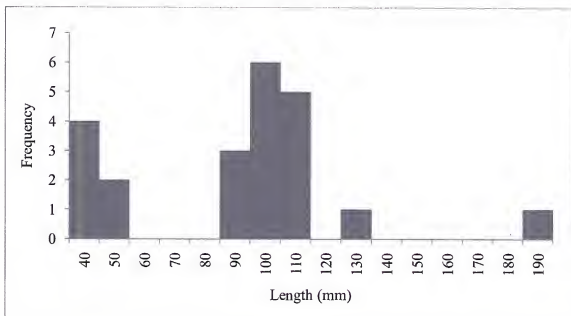
Length distribution of westslope cutthroat trout collected in the ditch at RM 6.2 on the Ross Fork Rock Creek below the headgate in 2009 (n=22).

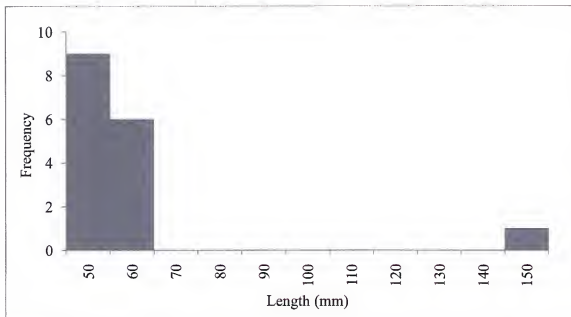
Length distribution of westslope cutthroat trout collected in the ditch at RM 6.0 on the Ross Fork Rock Creek below the headgate in 2009 (n=16).

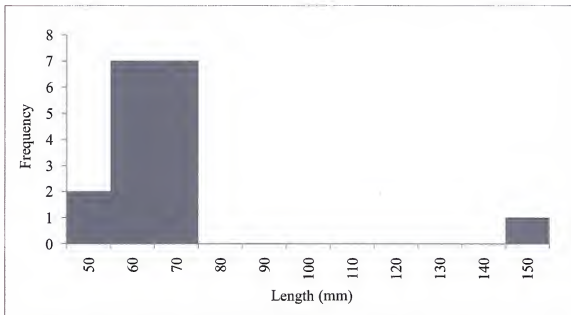
Length distribution of brown trout collected in the ditch at RM 6.0 on the Ross Fork Rock Creek below the headgate in 2009 (n=17).

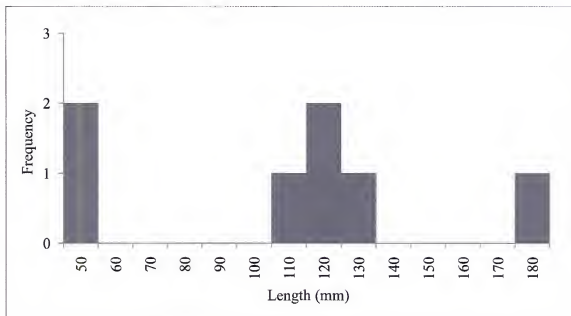
Length distribution of westslope cutthroat trout collected in the ditch at RM 5.5 on the Ross Fork Rock Creek below the headgate in 2009 (n=7).

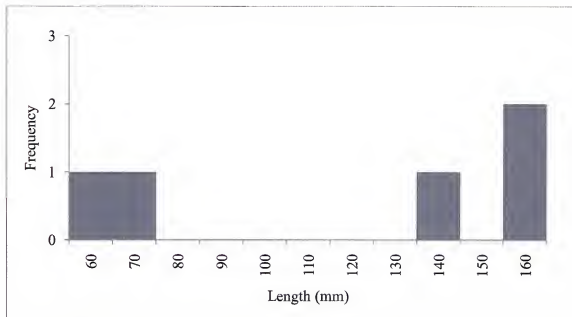
Length distribution of brown trout collected in the ditch at RM 0.1 on Middle Fork Rock Creek 0.2 mi below the headgate in 2010 (n=5).

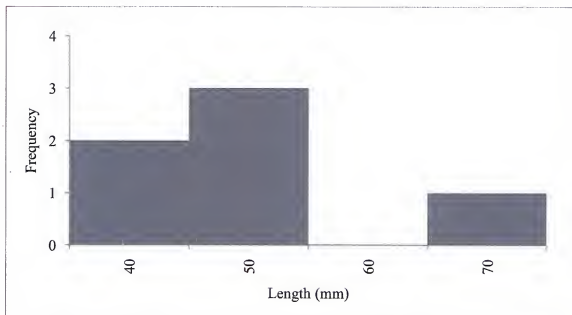
Length distribution of mountain whitefish collected in the ditch at RM 0.1 on Middle Fork Rock Creek 0.5 mi below the headgate in 2010 (n=6).

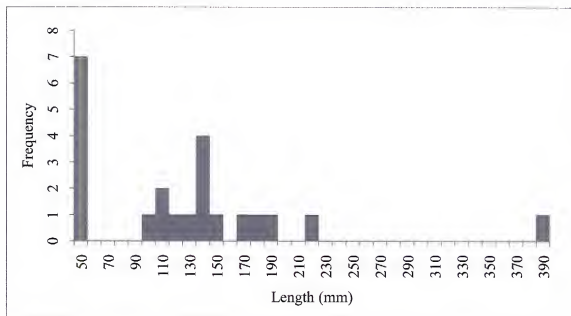
Length distribution of westslope cutthroat trout collected in Flint Creek Main Canal below the headgate in 2008 (n=22).

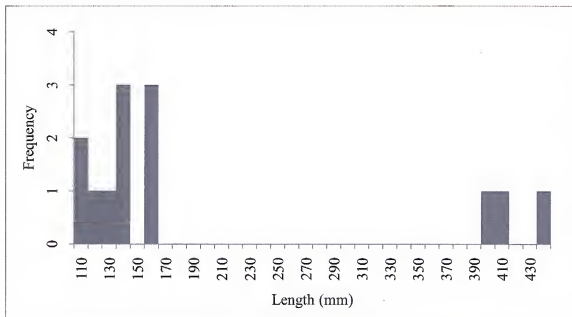
Length distribution of westslope cutthroat trout collected in Flint Creek Main Canal below the headgate in 2009 (n=13).

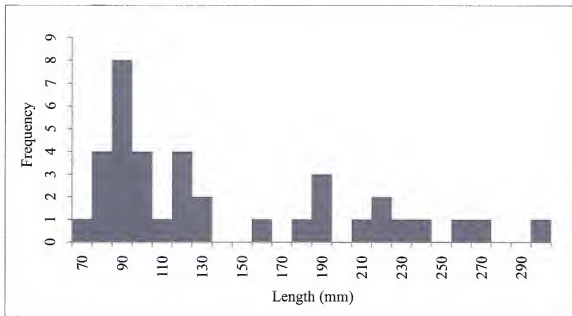
Length distribution of eastern brook trout collected in Flint Creek Main Canal below the headgate in 2009 (n=37).

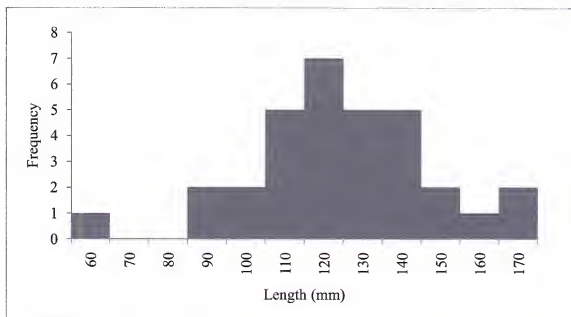
Length distribution of westslope cutthroat trout collected in Flint Creek Main Canal below the headgate in 2010 (n=32).

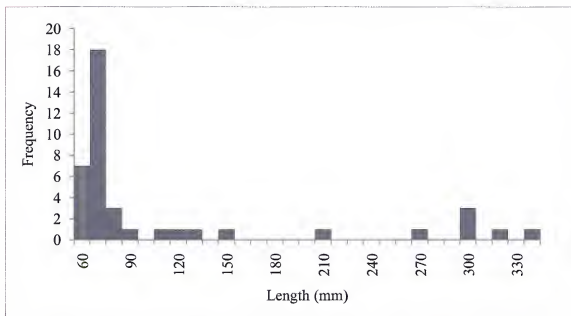
Length distribution of brown trout collected in Flint Creek Main Canal below the headgate in 2010 (n=40).

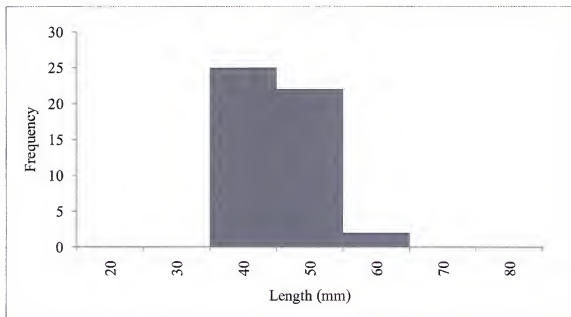
Length distribution of unidentified *Oncorhynchus* species collected in Flint Creek Main Canal below the headgate in 2010 (n=49).

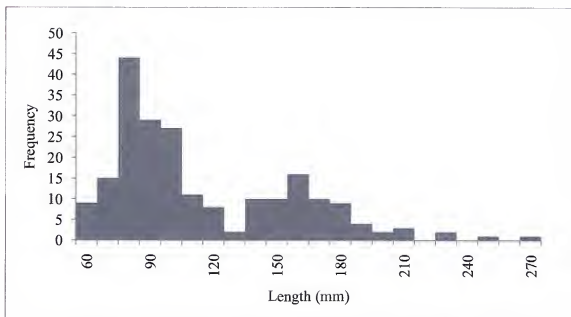
Length distribution of eastern brook trout collected in Flint Creek Main Canal below the headgate in 2010 (n=213).

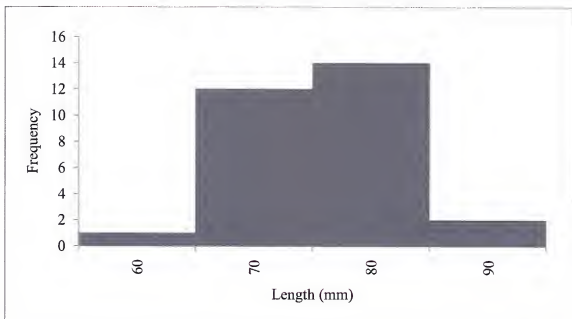
Length distribution of brown trout collected in the ditch at RM 0.01 on Harvey Creek below the headgate in 2010 (n=29).

In late August 2010, two electrofishing surveys were completed in a ditch on Harvey Creek (Figure 1). The ditch is located just upstream from the mouth (RM 0.01) and was also receiving water diverted from the Clark Fork River. This ditch was selected because in mid-June 2009, a radio-tagged bull trout was found dead approximately 0.8 mi below its headgate (see Radio Telemetry Results). This ditch is outfitted with a metal R-5 style headgate, and a wood pin and plank structure diverts water from Harvey Creek, as well as the ditch drawing water from the Clark Fork River. In a 100 m section below the headgate, 29 brown trout and eight unidentifiable *Oncorhynchus* species were collected (Table 10). Slimy sculpin were also present, but rare. The second section was located approximately 0.8 mi below the headgate. A small number of fish were collected in this section, including one unidentifiable *Oncorhynchus* species and a few longnose sucker. Due to the addition of water from the Clark Fork River it is difficult to know whether these fish originated from Harvey Creek or the Clark Fork River.

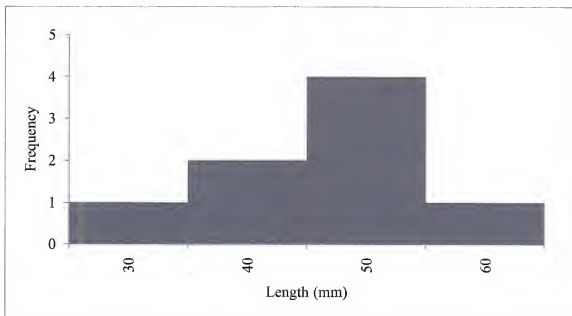
Length distribution of unidentifiable *Oncorhynchus* species collected in the ditch at RM 0.01 on Harvey Creek below the headgate in 2010 (n=29).

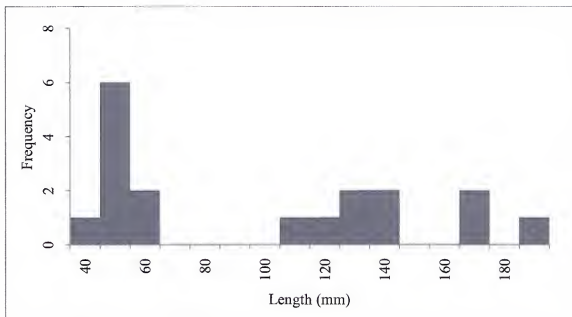
Length distribution of westslope cutthroat trout collected in the ditch at RM 2.9 on South Fork Lower Willow Creek below the headgate in 2009 (n=18).

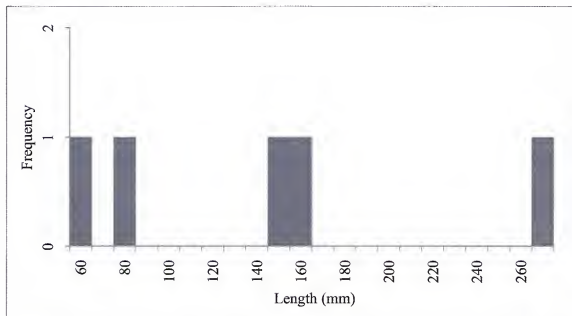
Length distribution of westslope cutthroat trout collected in the ditch at RM 0.9 on Boulder Creek below the headgate in 2009 (n=5).

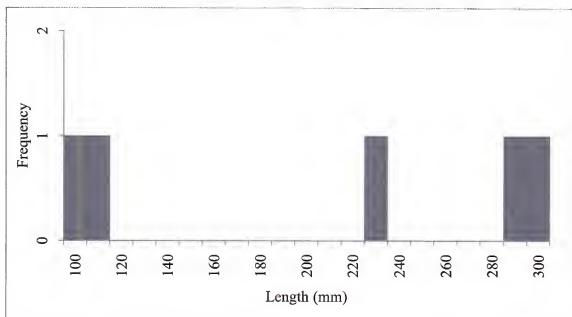
Length distribution of brown trout collected in the ditch at RM 0.9 on Boulder Creek below the headgate in 2009 (n=5).

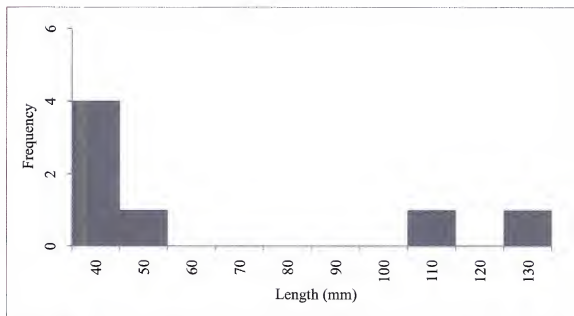
Length distribution of westslope cutthroat trout collected in the ditch at RM 0.8 on Boulder Creek below the headgate in 2009 (n=7).

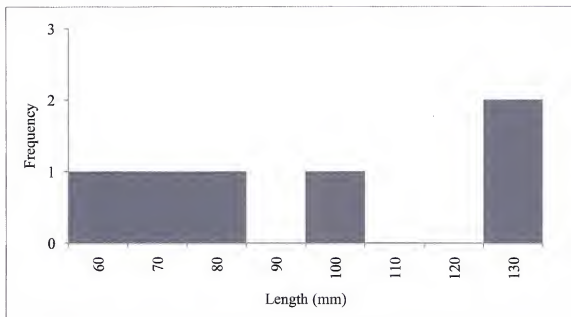
Length distribution of westslope cutthroat trout collected in the ditch at RM 0.9 on Boulder Creek below the headgate in 2010 (n=6).

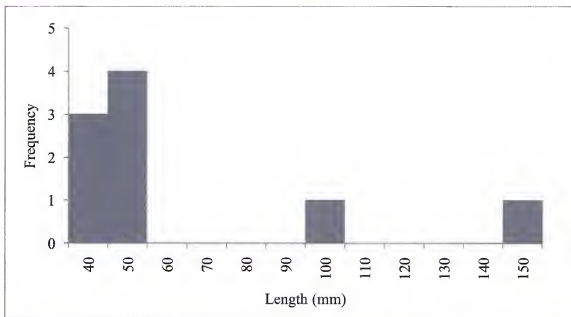
Length distribution of brown trout collected in the ditch at RM 0.9 on Boulder Creek below the headgate in 2010 (n=9).

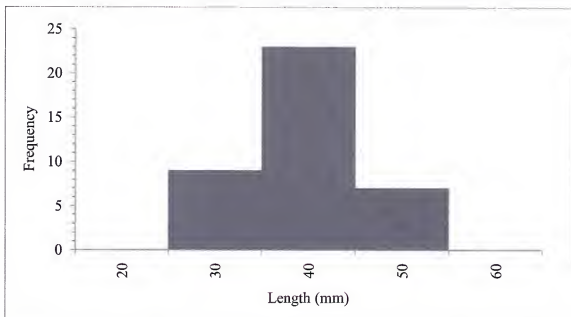
Length distribution of brown trout collected in the ditch at RM 0.8 on Boulder Creek below the headgate in 2010 (n=39).

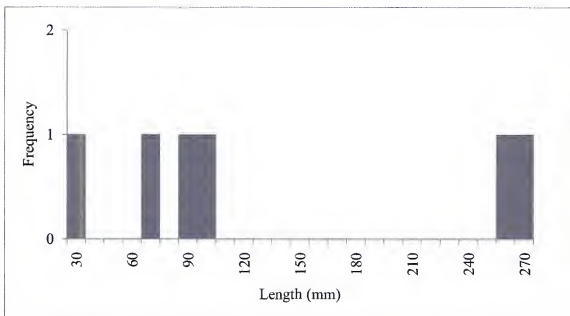
Length distribution of westslope cutthroat trout collected in the ditch at RM 0.8 on Boulder Creek below the headgate in 2010 (n=6).

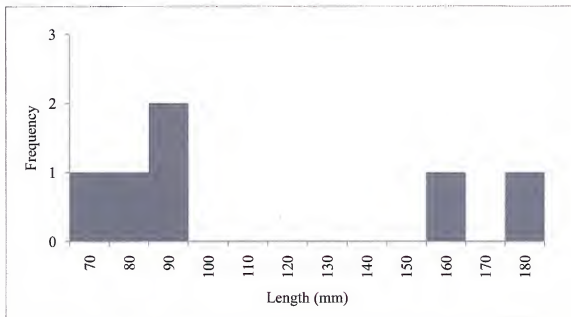
Length distribution of westslope cutthroat trout collected in the ditch at RM 0.2 on Boulder Creek below the headgate in 2010 (n=6).

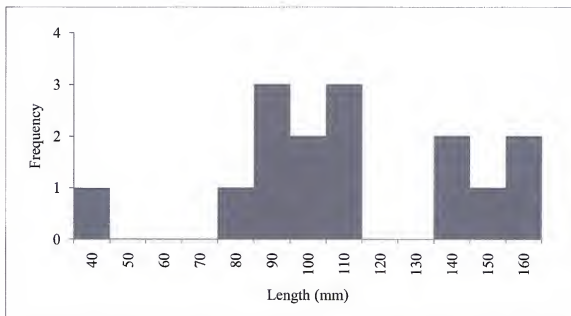
Length distribution of westslope cutthroat trout collected in the ditch at RM 6.1 on Gold Creek below the diversion in 2010 (n=15).

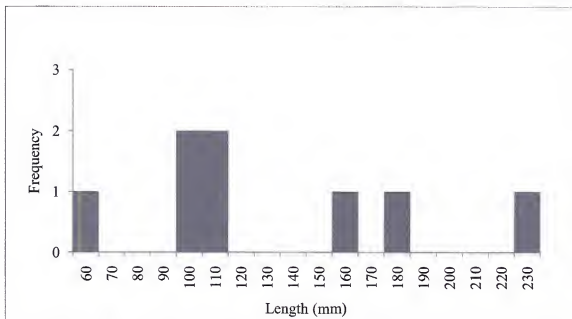
Length distribution of brown trout collected in the ditch at RM 6.1 on Gold Creek below the diversion in 2010 (n=8).

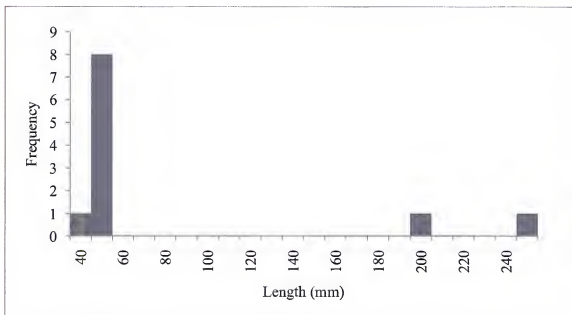
Length distribution of brown trout collected in the ditch at RM 5.2 on Gold Creek below the diversion in 2010 (n=11).

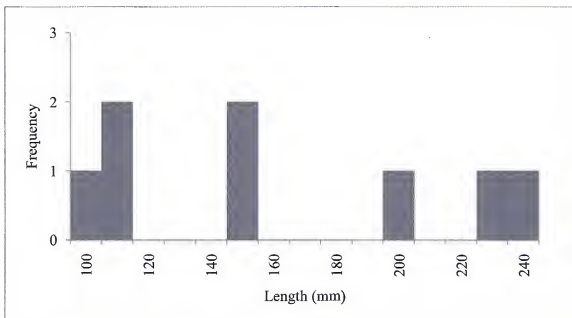
Length distribution of westslope cutthroat trout collected in the ditch at RM 5.2 on Gold Creek below the diversion in 2010 (n=8).

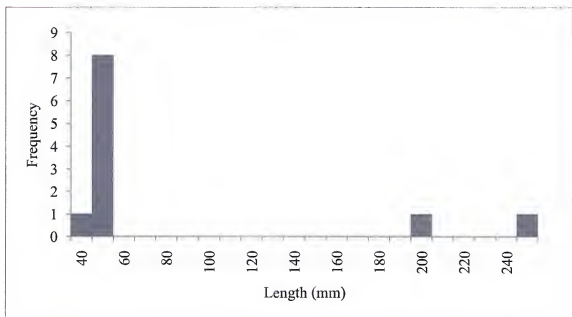
Length distribution of brown trout collected in the ditch at RM 5.2 on Gold Creek below the diversion in 2010 (n=11).

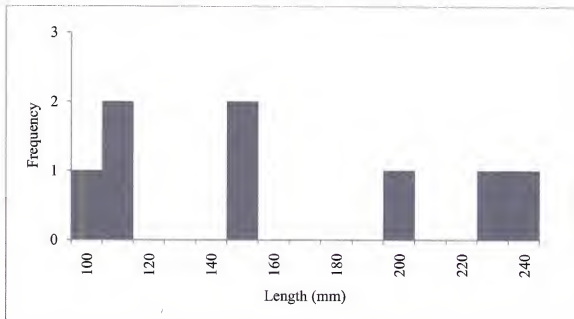
Length distribution of westslope cutthroat trout collected in the ditch at RM 5.2 on Gold Creek below the diversion in 2010 (n=8).

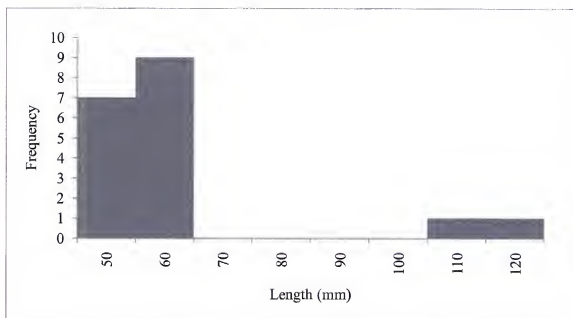
Length distribution of brown trout collected in the ditch at RM 3.9 on Gold Creek below the diversion in 2010 (n=18). An additional 102 brown trout were collected but not measured individually (ranged 50-70 mm).

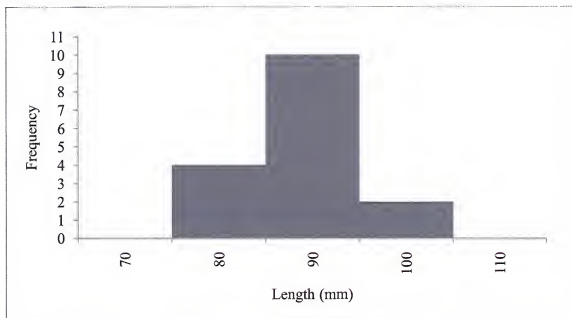
Length distribution of westslope cutthroat trout collected in the ditch at RM 3.9 on Gold Creek below the diversion in 2010 (n=16).

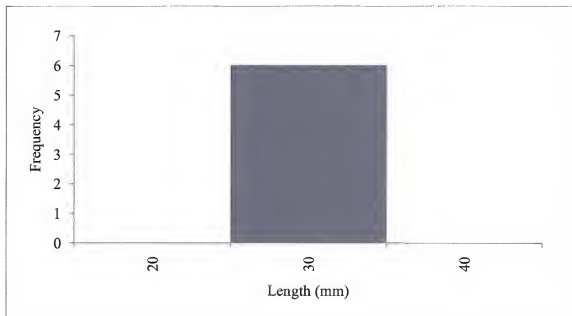
Length distribution of unidentifiable *Oncorhynchus* species collected in the ditch at RM 3.9 on Gold Creek below the diversion in 2010 (n=6).

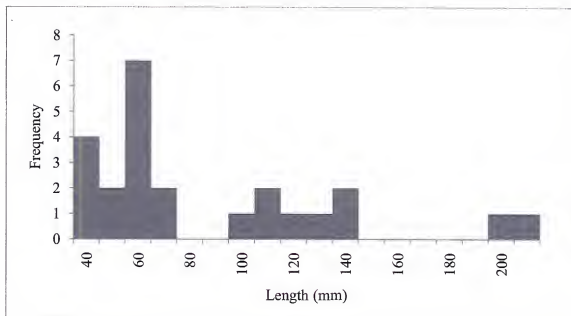
Length distribution of brown trout collected in the ditch at RM 3.8 on Gold Creek below the diversion in 2010 (n=24). An additional 134 brown trout were collected but not measured individually (ranged 50-70 mm).

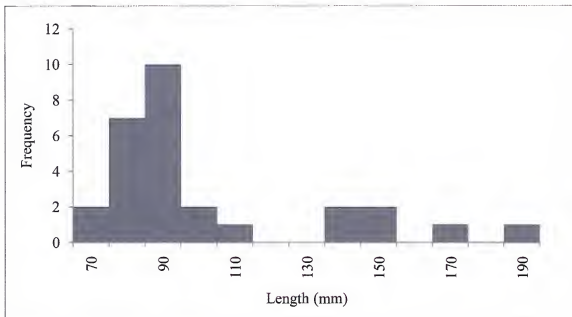
Length distribution of westslope cutthroat trout collected in the ditch at RM 3.7 on Gold Creek below the diversion in 2010 (n=28).

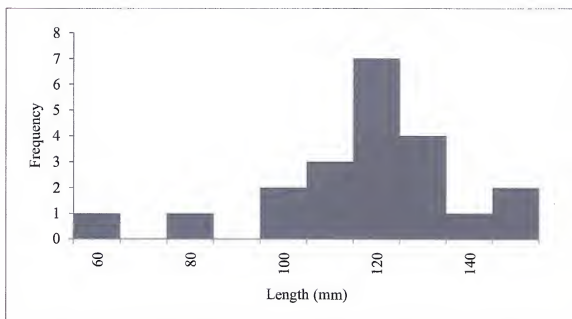
Length distribution of brown trout collected in the ditch at RM 3.7 on Gold Creek below the diversion in 2010 (n=21). An additional 20 brown trout were collected but not measured individually (ranged 50-70 mm).

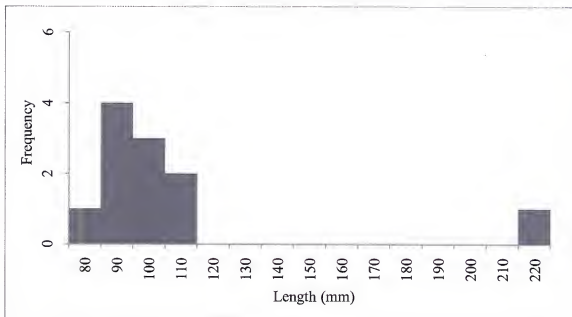
Length distribution of westslope cutthroat trout collected in the ditch at RM 3.6 on Gold Creek below the headgate in 2007 (n=11).

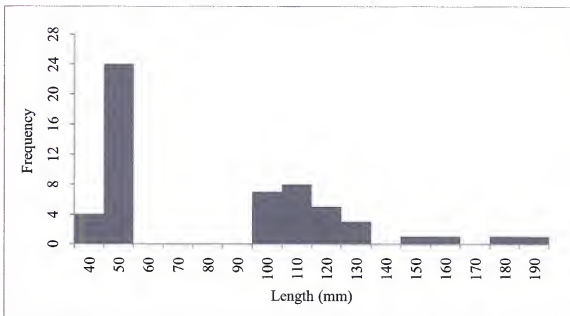
Length distribution of brown trout collected in the ditch at RM 3.6 on Gold Creek below the headgate in 2007 (n=55).

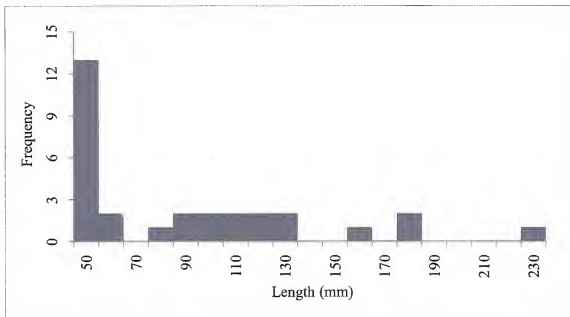
Length distribution of brown trout collected in the ditch at RM 3.6 on Gold Creek below the headgate in 2009 (n=30).

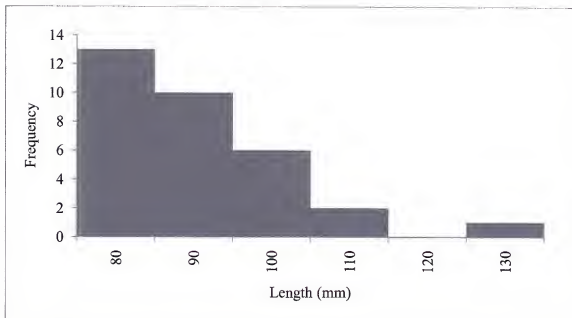
Length distribution of westslope cutthroat trout collected in the ditch at RM 3.6 on Gold Creek below the diversion in 2010 (n=32).

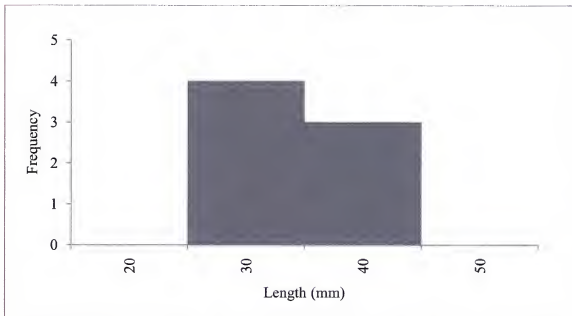
Length distribution of unidentified *Oncorhynchus* species collected in the ditch at RM 3.6 on Gold Creek below the headgate in 2010 (n=7).

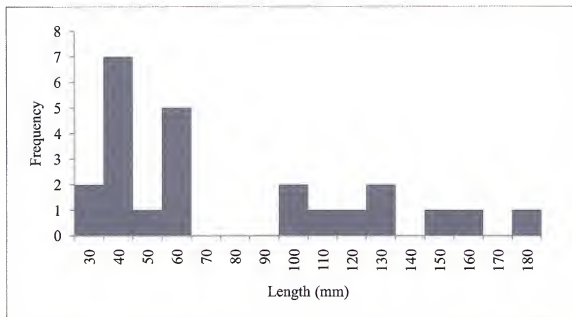
Length distribution of brown trout collected in the ditch at RM 1.1 on Gold Creek below the headgate in 2010 (n=24). An additional 137 brown trout were collected but not measured individually (ranged 40-70 mm).

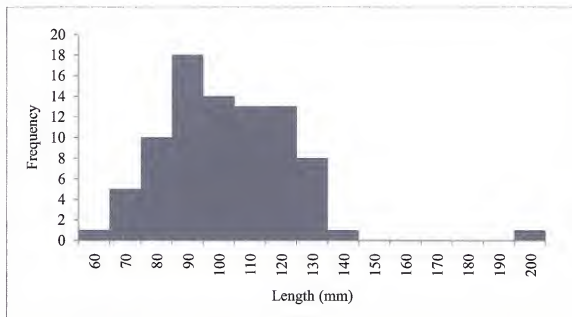
Length distribution of brown trout collected in the Kohrs-Manning ditch below the headgate in 2010 (n=84).

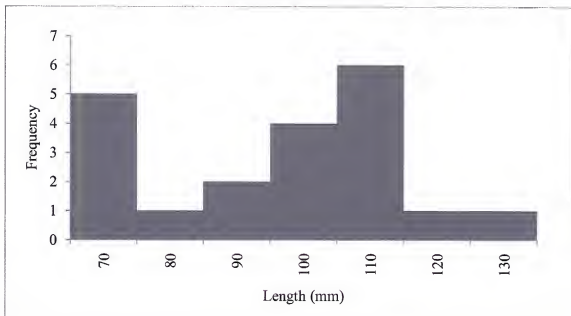
Length distribution of brown trout collected in Kohrs-Manning ditch below the intersection with Cottonwood Creek in 2010 (n=20).

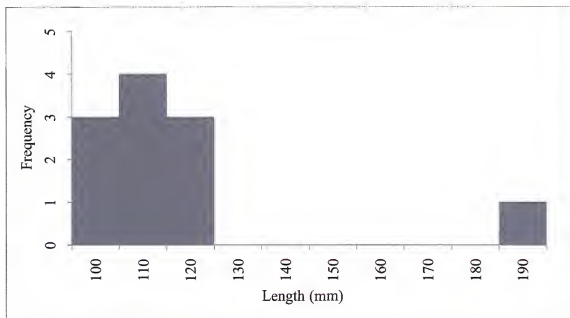
Length distribution of eastern brook trout collected in the ditch at RM 3.5 on Cottonwood Creek below the headgate in 2009 (n=11).

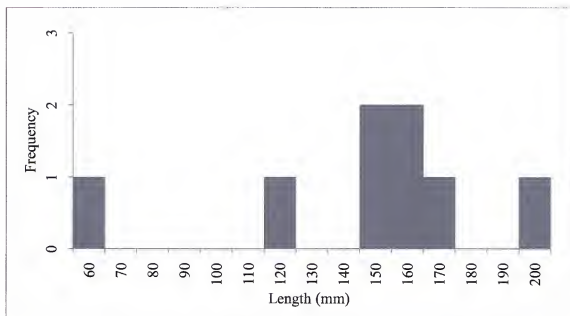
Length distribution of eastern brook trout collected in the ditch at RM 3.0 on Cottonwood Creek below the headgate in 2009 (n=8).

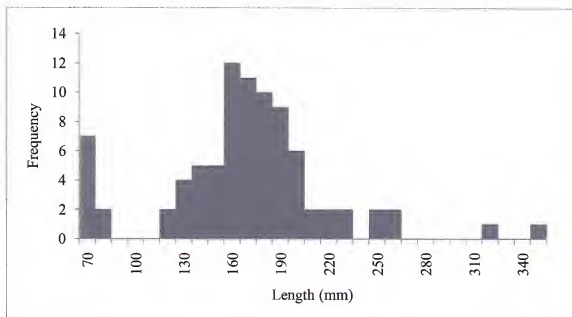
Length distribution of brown trout collected in the ditch at RM 4.8 on Dempsey Creek below the headgate in 2010 (n=85).

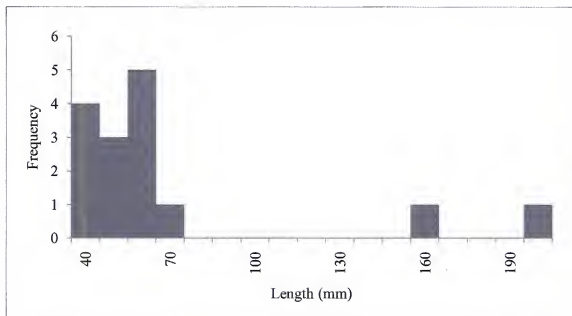
Length distribution of brown trout collected in the ditch at RM 7.5 on Racetrack Creek below the headgate in 2010 (n=15).

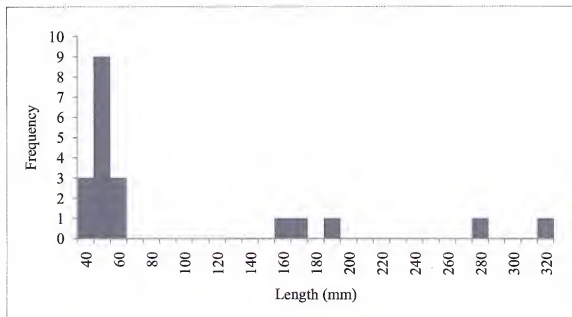
Length distribution of brown trout collected in the ditch at RM 7.4 on Racetrack Creek below the headgate in 2010 (n=20).

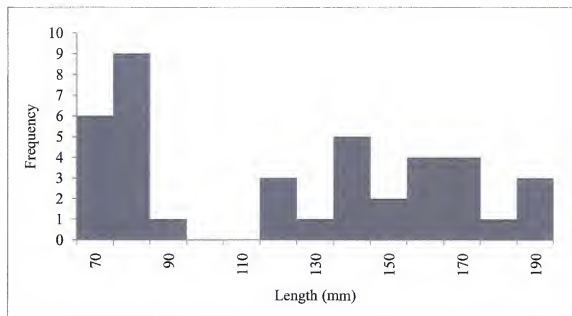
Length distribution of brown trout collected in the ditch at RM 3.5 on Racetrack Creek below the headgate in 2010 (n=39).

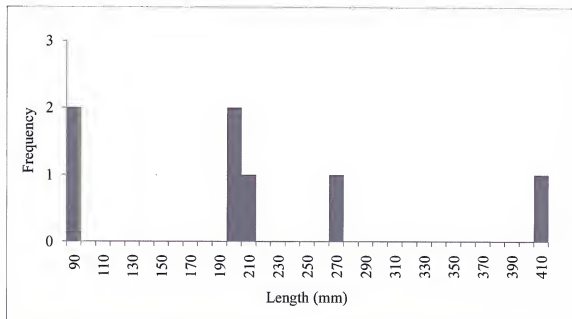
Length distribution of eastern brook trout collected in the ditch at RM 9.2 on Lost Creek below the headgate in 2010 (n=9).

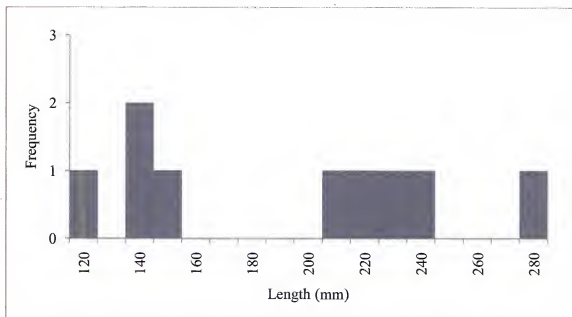
Length distribution of brown trout collected in the ditch at RM 9.2 on Lost Creek below the headgate in 2010 (n=7).

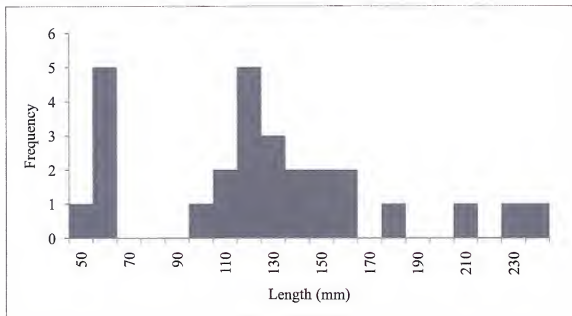
Length distribution of brown trout collected in the ditch at RM 10.0 on Warm Springs Creek 2.0 miles below the headgate in 2010 (n=27). Section located below an intersection with Lost Creek, and thus many of the fish collected may have originated from Lost Creek.

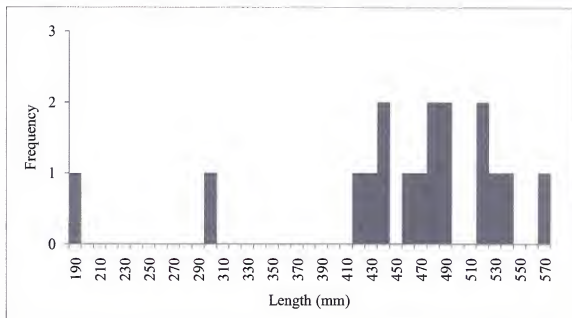
Length distribution of bull trout collected below water control structure barrier on Storm Lake Creek in 2010 (n=17).
